Lift the withering spell off those ailing ceramic filters!

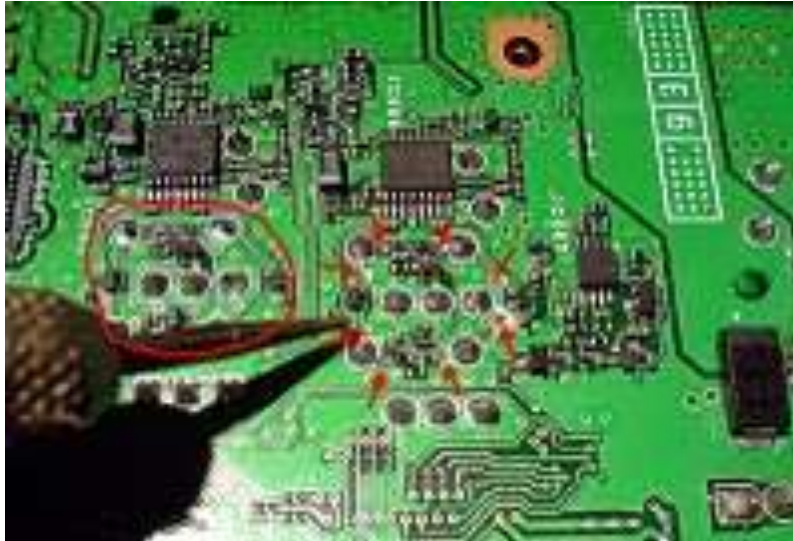
The **first photo** shows (with the red arrows) the eight traces to be cut with a **very fine-tip** grinding tool. Notice that there are 16 cuts for the 710, eight are shown completed, the other eight are in the red circle on the left (the circuit topology is identical).

First of all, take a look at the photo on the left (*click on the pictures to enlarge*). There are **four ceramic filters in the '710**, two (wide-narrow) for each receiver. Our first step is to cut two PCB traces converging at each filter's input and output pins, bridge them, and then solder a size 1306, 0.1 μ F / 25V or 50V SMD ceramic capacitor from each bridge to the filter's input and output pins (**8 capacitors** in all

for the '710). This way, the DC switching voltage is blocked by the capacitor, that passes only the small AC (signal) component into and out of the filter. Removing the DC bias from the filters is all that is needed to avoid filter failure.

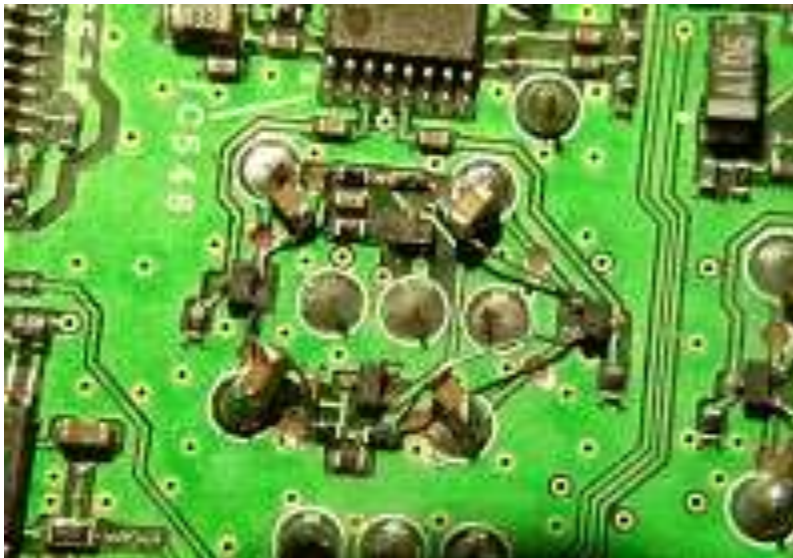
Take a look at the **second photo** (*click to enlarge*), showing the completed job for a filter set. As you see, **fine wire bridges** have been soldered, bypassing the cut-off portion of the circuit that was going to the filter pins, and the ceramic capacitors are also in place, soldered between the wire bridges and the filter's input / output pins.

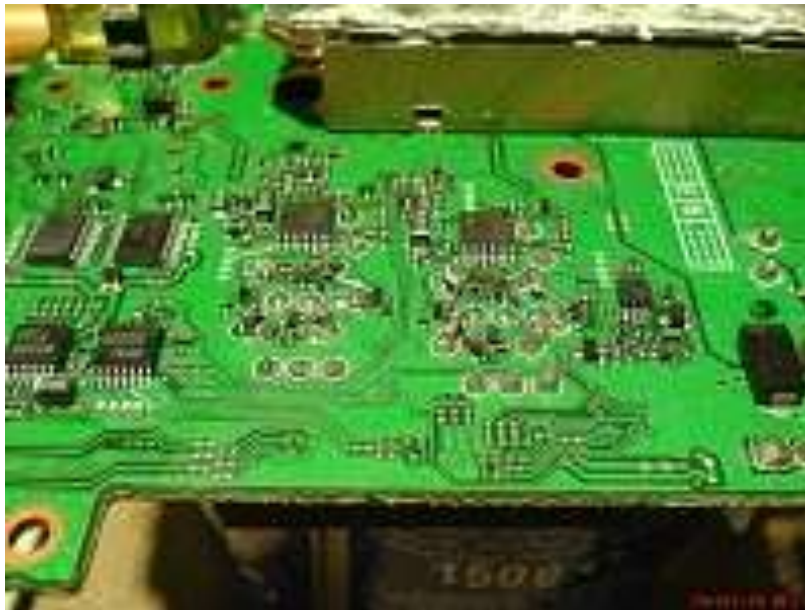
The **third photo** (*click to enlarge*) shows the completed job for all four filters. **I must say**, that although very simple, this mod is a bit difficult because of the very small dimensions of the traces and SMD components. **Extreme care** is required, along with the **proper tools** and ability to work with them. **It's easy to make a disaster out of the job**, so please be careful!! If you don't feel up to the job, have somebody qualified to do it!
